Manhole Inspection Summary

Manhole # S41E__032MH

Insp Date: **7/25/08 1:10 PM**

Location Address: **1200 aisquith st**

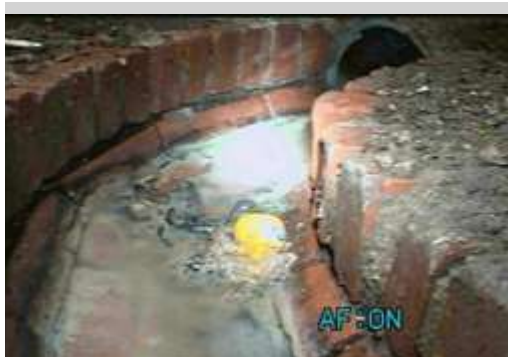
Misc

channel debris

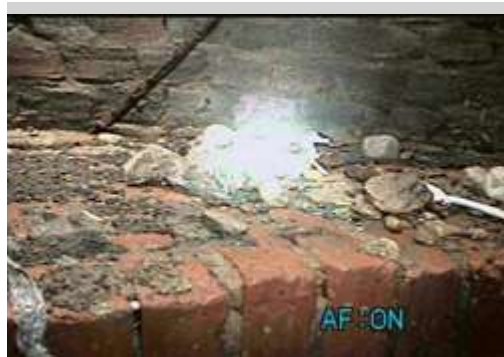
Misc

bench debris

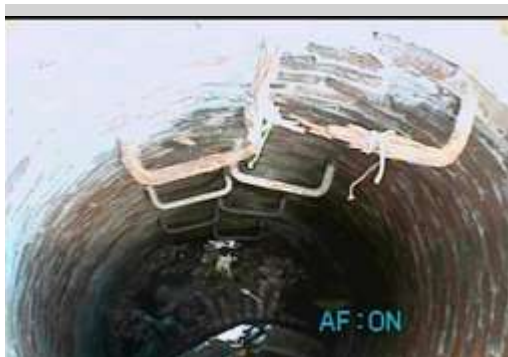
Defect 2

Steps Count: **7** Missing: **0** ☒ **Corroded**

steps

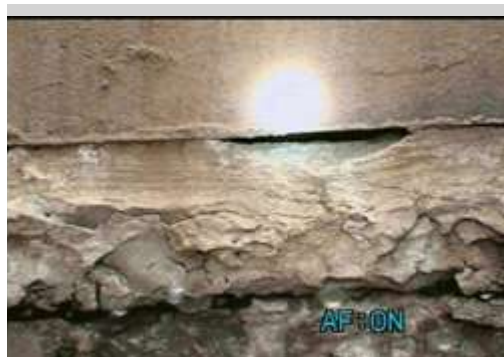
Defect 1

Chimney / Frame Adjustment ☒ Exists Material: **Brick and Concrete** ☐ Parged Height: **4** (in.)

Condition: ☐ Sound ☒ **Cracked** ☐ Root Intrusion ☐ Loose Brick ☒ **Deteriorated**

chimney cond cracked, chimney cond deteriorated

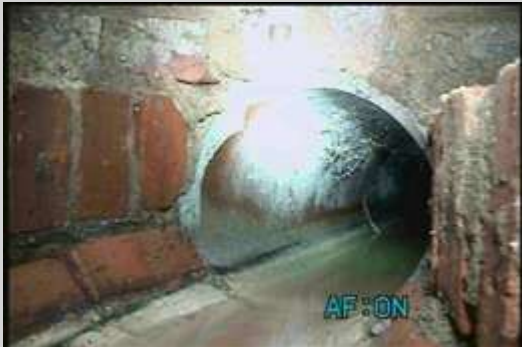
12 O'Clock Outflow

8 in. Circular Gravity Sewer
Pipe Out @ 12 O'Clock

Invert Depth: 11.30 (ft.) Flow Characteristics: **Fast**

Infiltration: **None** Pipe Seal Cond: **Unknown**

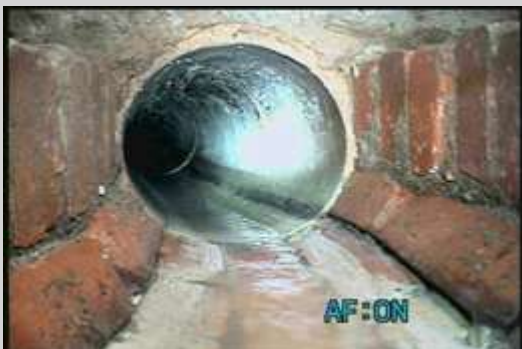
4 O'Clock Inflow

8 in. Circular Gravity Sewer
Pipe In @ 4 O'Clock

Invert Depth: 11.20 (ft.) Flow Characteristics: **Fast**

Infiltration: **None** Pipe Seal Cond: **Unknown**
